When the bishops ruled

Like a lot of the properties English Heritage is responsible for, the Medieval Bishops' Palace in Lincoln is a ruin. Yet these ruins of what was once one of the most important buildings in the country are an invaluable record of a time when Lincoln was the administrative centre of the largest diocese in England, stretching from the Humber to the Thames. To preserve that significance, £2.5million is now being spent on conserving the ancient stonework.

Medieval Bishops' Palace

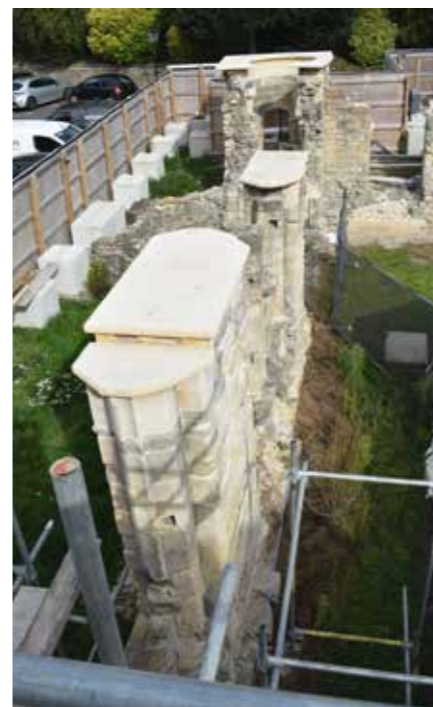
Photo: English Heritage

Above. An aerial view of the Medieval Bishops' Palace site before work started.

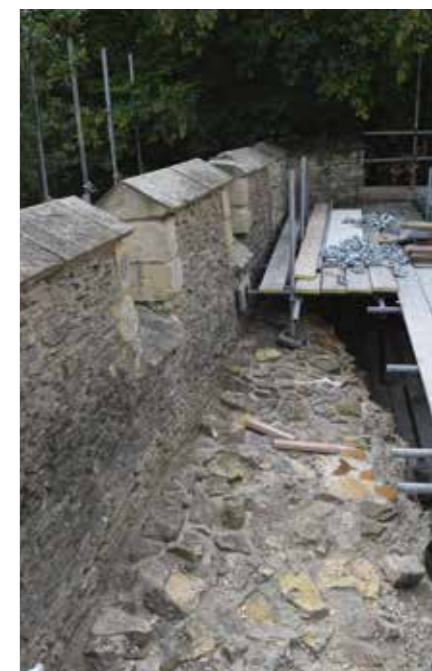
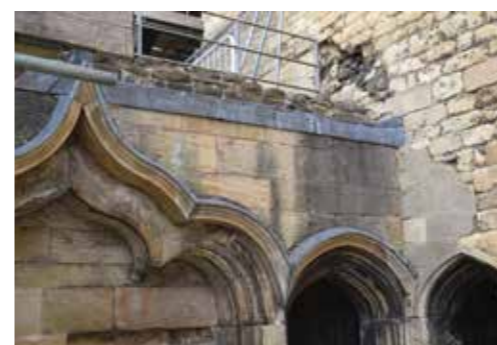
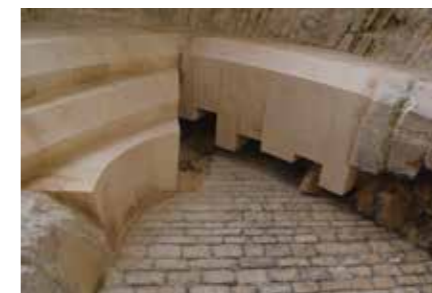
Left. The three pictures on the left show examples of the different kinds of capping used at the Medieval Bishops' Palace. The top picture shows hard capping in Ancaster limestone, which was used at higher levels because it should require less attention than the soft 'sustainable conservation' capping in the picture below it, created by putting turf on top of the more accessible, lower level walls. By the end of a particularly dry summer this year the grass looked as if it had died, although with the return of some rain it is showing signs of recovery. Historic England trials have shown that soft capping with turf sheds excess water, protecting the walls underneath and avoiding water run-off streaking. The picture below that shows how lead has also been used to protect mouldings. It has been used on the kitchen high level, it having been decided that a mixture of different approaches across the site offered the best solution to protecting the ruins.

One reason for the deterioration seen in the walls is that the stone used for interior walls was not the best, as it was not intended to be exposed to the weather. A roof would have provided protection and part of the current work has been to replace that kind of protection by capping the walls. Various methods have been used. At higher levels there is hard capping, some using Ancaster limestone. There is lead protecting the kitchen high level. Lower down, there is soft capping, where the walls are topped with turf.

Soft cappings were developed as what is known as 'sustainable conservation' to protect stone ruins in a self-sustaining way. Soft cappings are permeable, but so are stone walls with lime mortars. Soft cappings shed water and can help prevent algal growth and streaking on the faces of walls and provide insulation to avoid freezing, which can be a cause of stone cracking and delaminating.

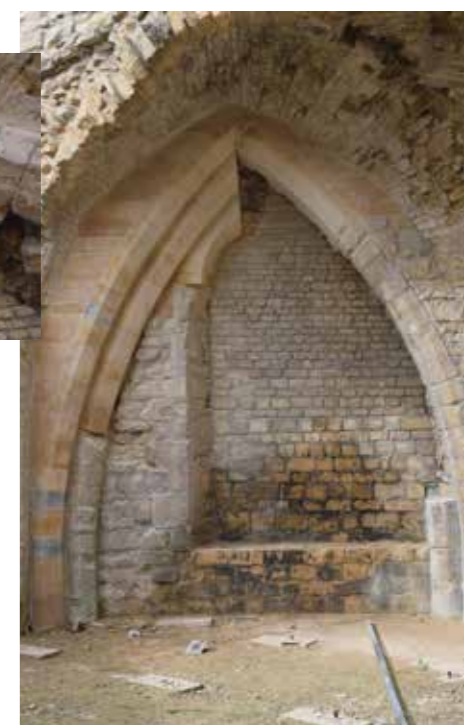
Right. The Roman boundary wall topped by a medieval parapet. Much of the wall has had to be rebuilt.

The fact that the Medieval Bishops' Palace is a ruin owes a lot to the civil wars of the 17th century. And while most of the fabric that remains dates back to the 13th century, a wall on the perimeter of the site separating it from neighbouring property is Roman, with a medieval parapet constructed on top of it. For structural integrity it was found to require a substantial degree of demolition and rebuilding, which had not been included in the original programme. "That was £100,000-worth of work that wasn't envisaged," says Fred Markland.

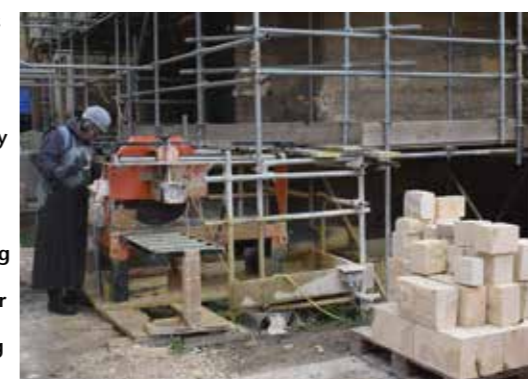
Right. Due to the varying requirements for stone it was more efficient to cut on-site. This accommodated constantly changing unforeseen stone requirements and reduced waste by using offcuts. It meant stock was readily available on-site with Messenger's own operatives on hand to cut it. One of them, Paul Hughes, is pictured here using the saw. This has avoided any misunderstandings arising from sending drawings and templates to a third party, which could have implications for the programme and has enabled the masons to physically check their setting out before doing any cutting.

Fred Markland, Messenger's Heritage & Conservation Senior Building Surveyor, told NSS: "Due to the various stone sizes needed on-site, it was more efficient to order the stone in slab form and then to cut the exact stone size required on-site using a site saw. This assisted with the constantly changing, unforeseen stone requirements by having stock readily available and meant we could find a use for much of the 'waste' removed from what we had sawn."

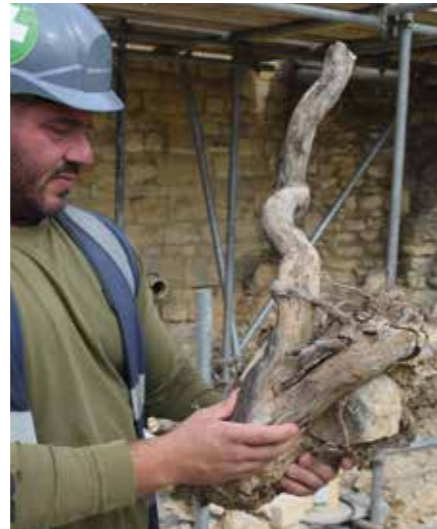
Site Manager Paddy Lilley with one of more than 1,000 plant roots removed from the walls.

It was not only hard cement that was playing its part in the deterioration of the walls. Valerian and ivy were also contributing, their thickening roots forcing the stones apart. Valerian is a particular problem because it is a popular garden plant and there is a lot of it in the precinct gardens of the cathedral. It self-seeds on the exposed stone walls and more than 1,000 plants had to be removed by Messenger. Keeping it off the walls will require on-going attention.

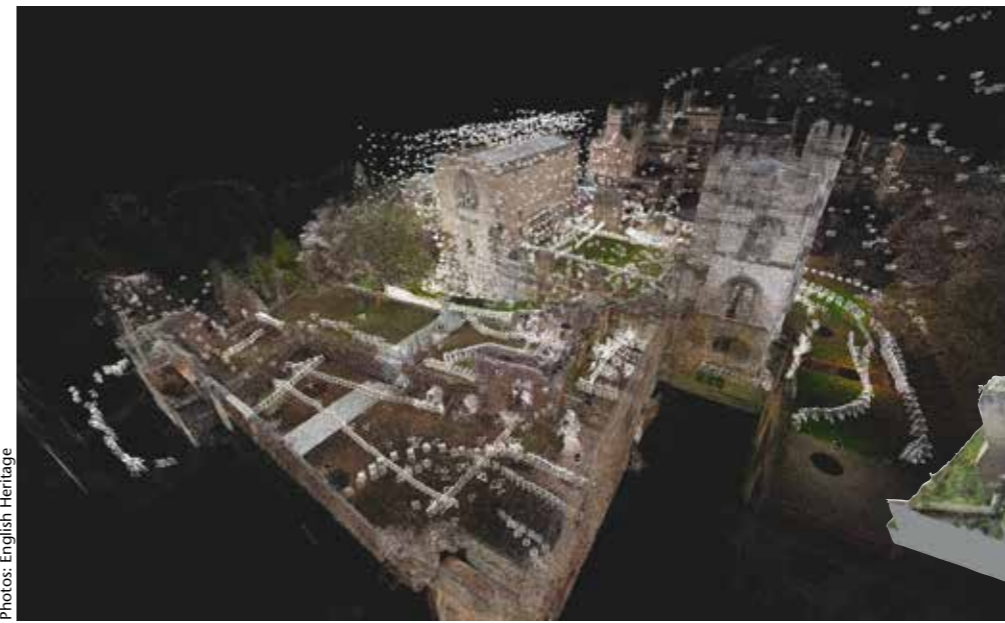
Photos: English Heritage

Point cloud laser scanning and photogrammetry have been used to create a precise 3D digital record of the Medieval Bishops' Palace in sufficient detail to be able to see individual stones.

The legacy of the project at the Medieval Bishops' Palace will not only be ruins that are safe to visit, but also a highly accurate and detailed record of the site thanks to point cloud laser scanning and photogrammetry that combine to create a precise 3D digital

record in sufficient detail to be able to see individual stones. It was one of the first English Heritage projects to be catalogued in this way, with English Heritage calling on its partners at Historic England to lend their expertise to carry out the scanning.

The data were then passed to the architects to mark out the stonework that needed attention. However, the scans were completed before Covid and after two fairly severe winters the walls were re-surveyed once the scaffolding had been erected.

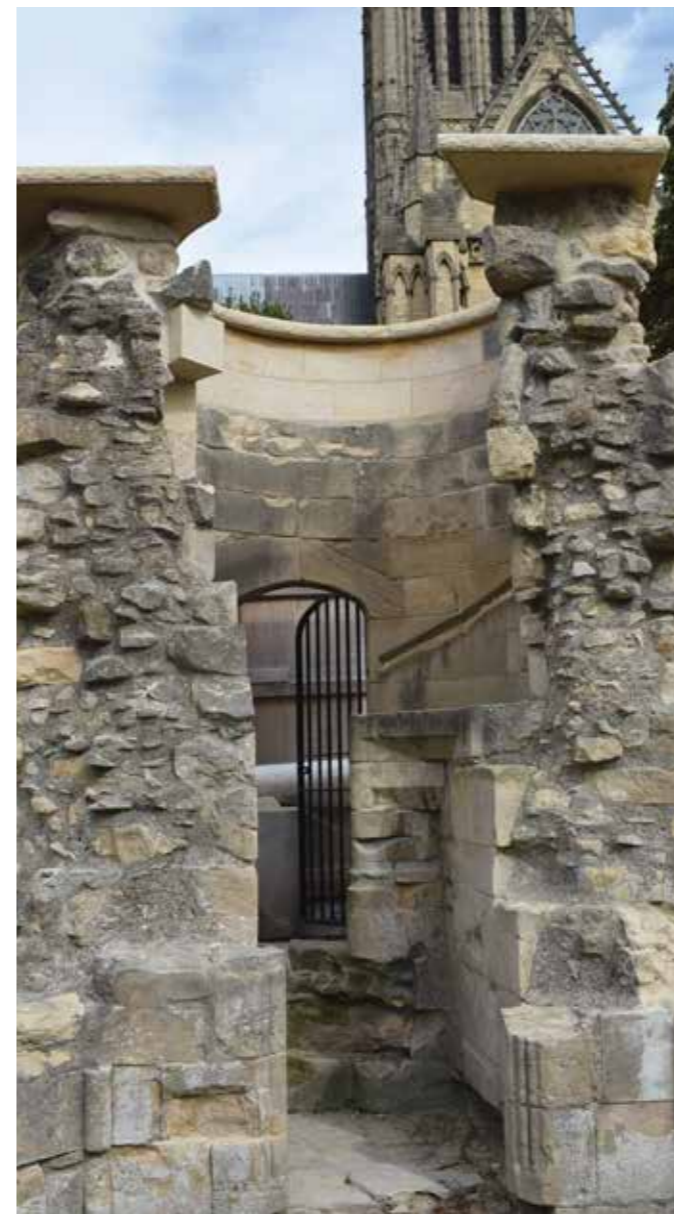
Left. This is one of the areas where extensive hard cement repairs made in the 1950s and '60s have been left in place because it was considered removing them would have caused more damage to the original fabric of the building than leaving them in situ. The top of the wall has been built in the Lincoln limestone and the wall has been capped with the stone.

Some of the cementitious consolidation from the mid-20th century is so extensive that it has not been removed as part of the current project. To do so would have been a major undertaking and it was felt it was also likely to lead to the loss of more of the original fabric of the walls, with some of the medieval masonry having even more extensive cracking than had been expected.

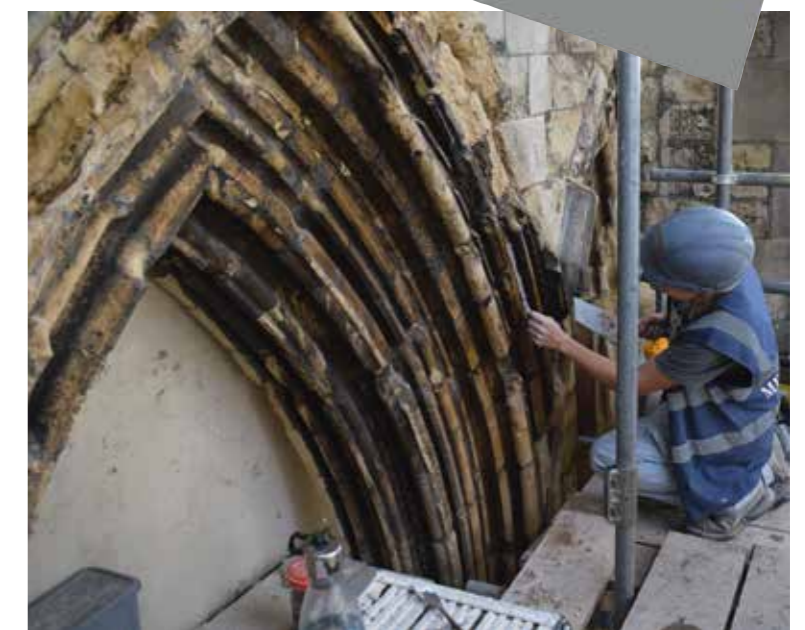
Right. Part of the vaulted undercroft.
